Situation Photo Log

Saturday, July 7, 2012

Kalamazoo River / Enbridge Spill

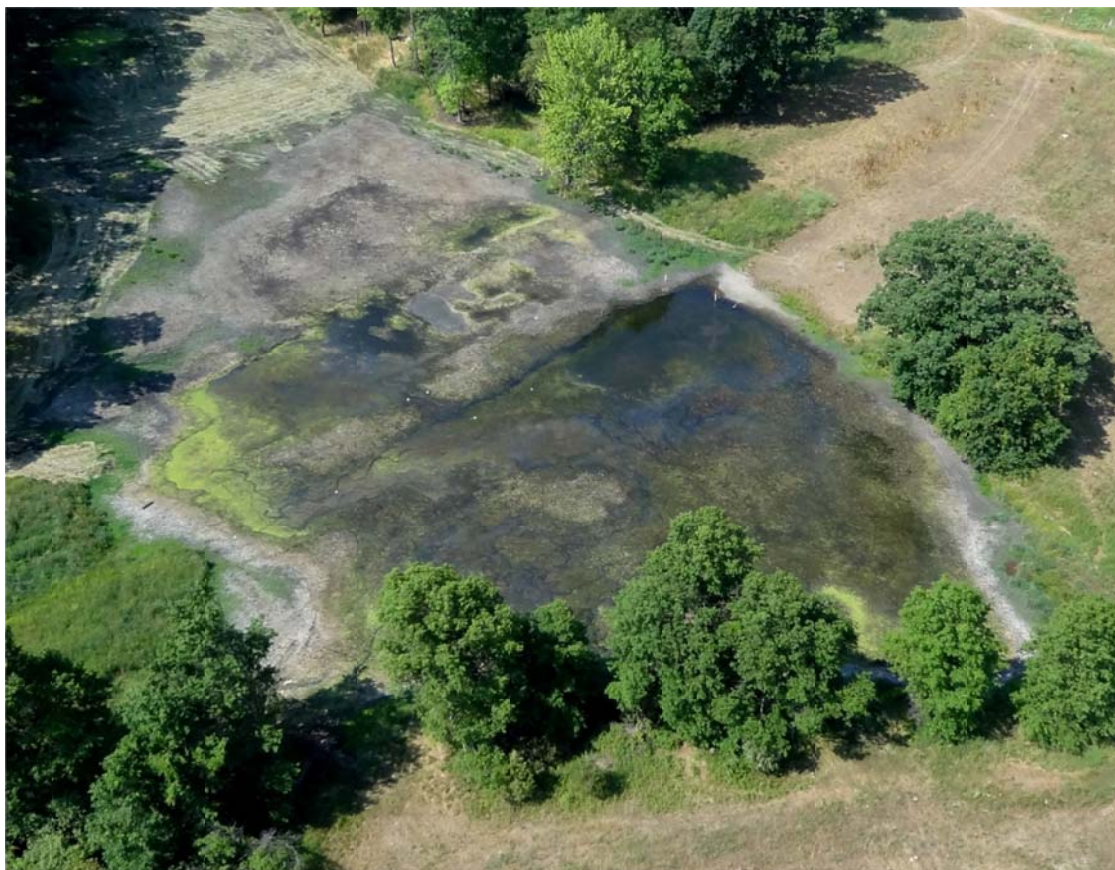
1. Source area pond, sheen observed.

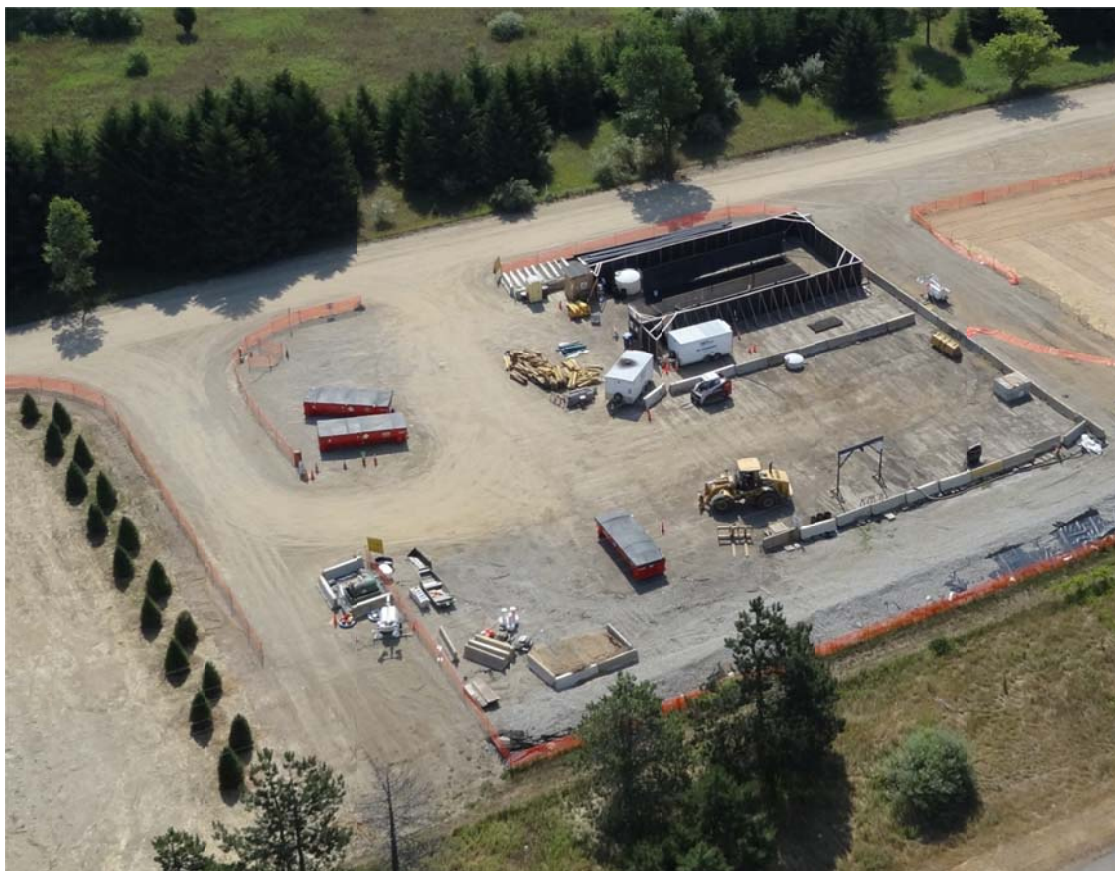
2. Frac-City, no activity observed.

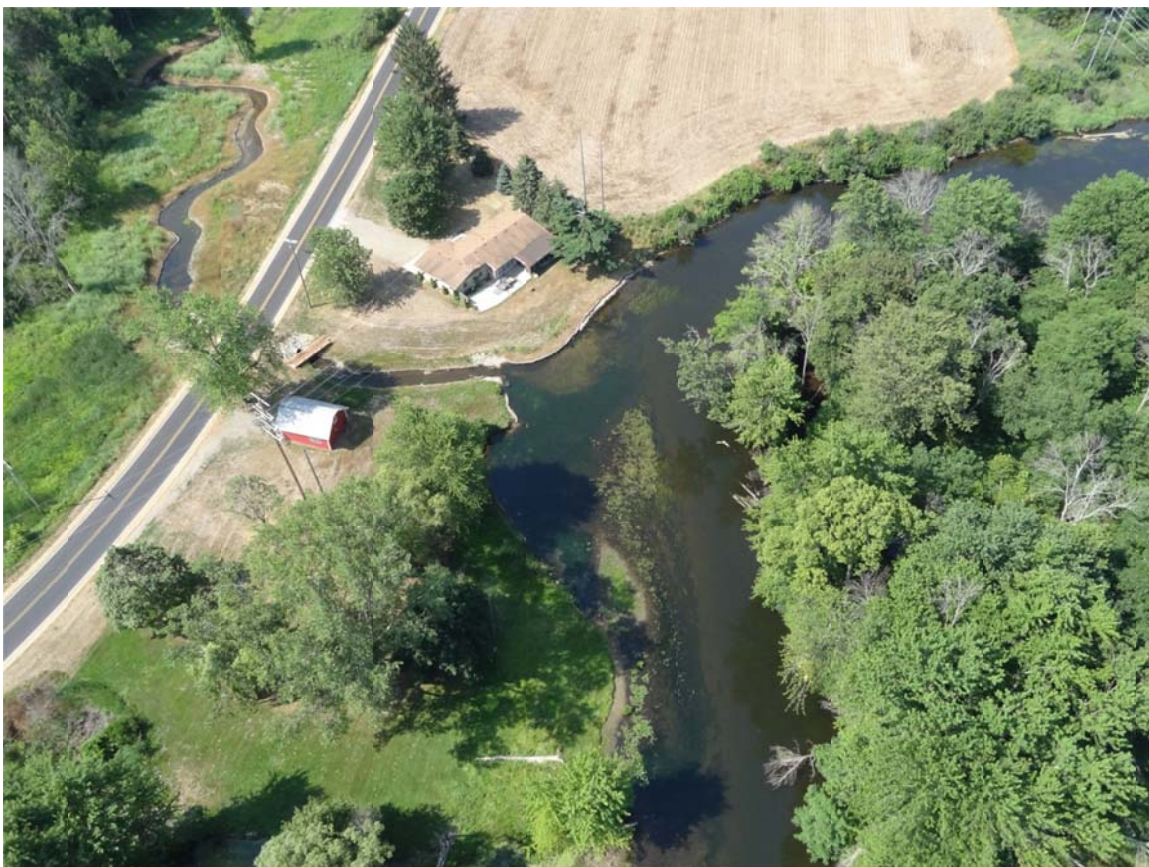
3. Confluence, no sheen observed.

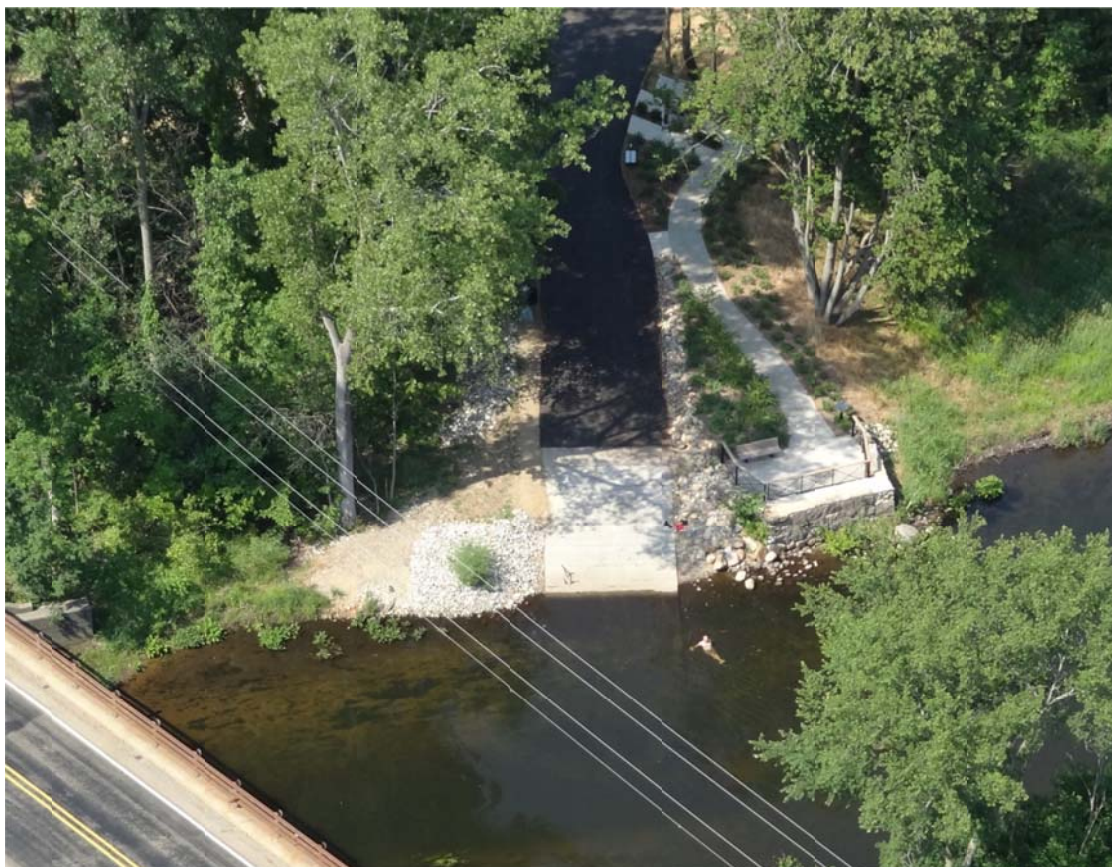
4. Observed swimmers at Saylor's Landing.

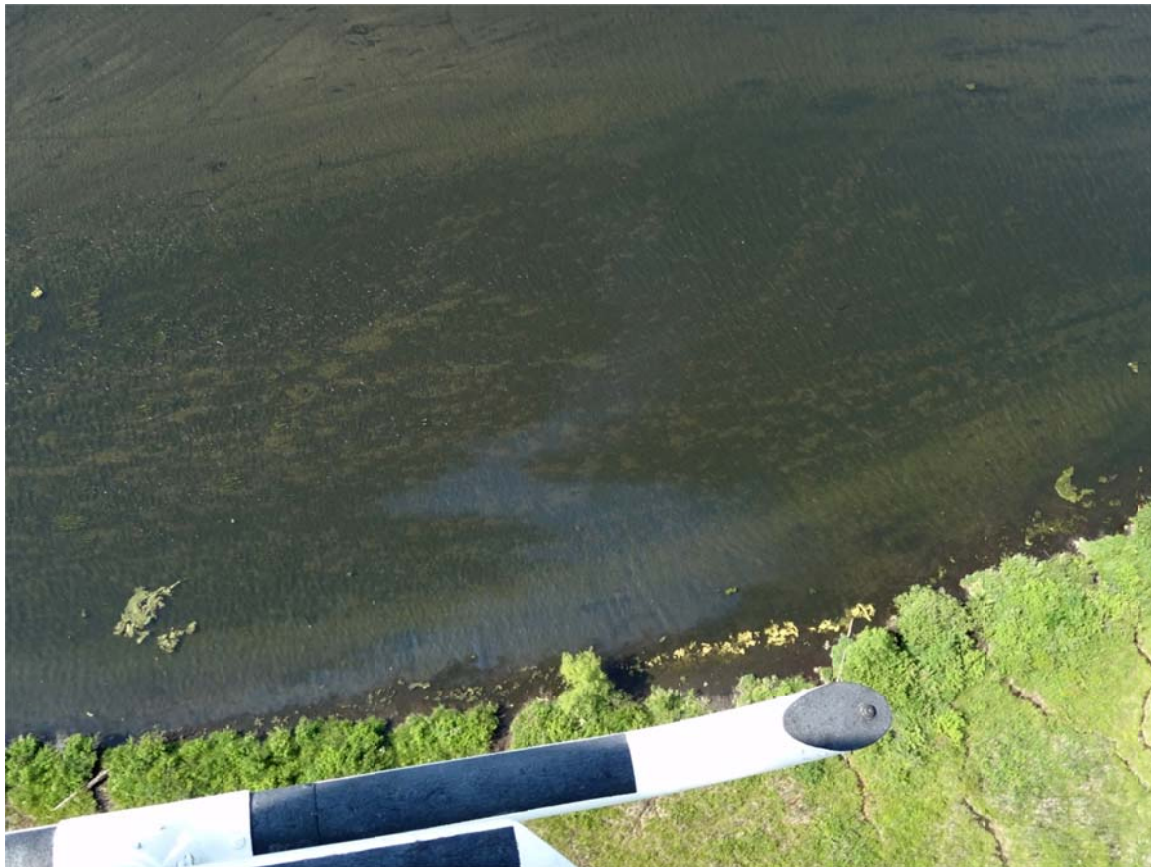
5. Sheen observed along RDB just downstream from C0.4 boat launch, sweeper boat notified.

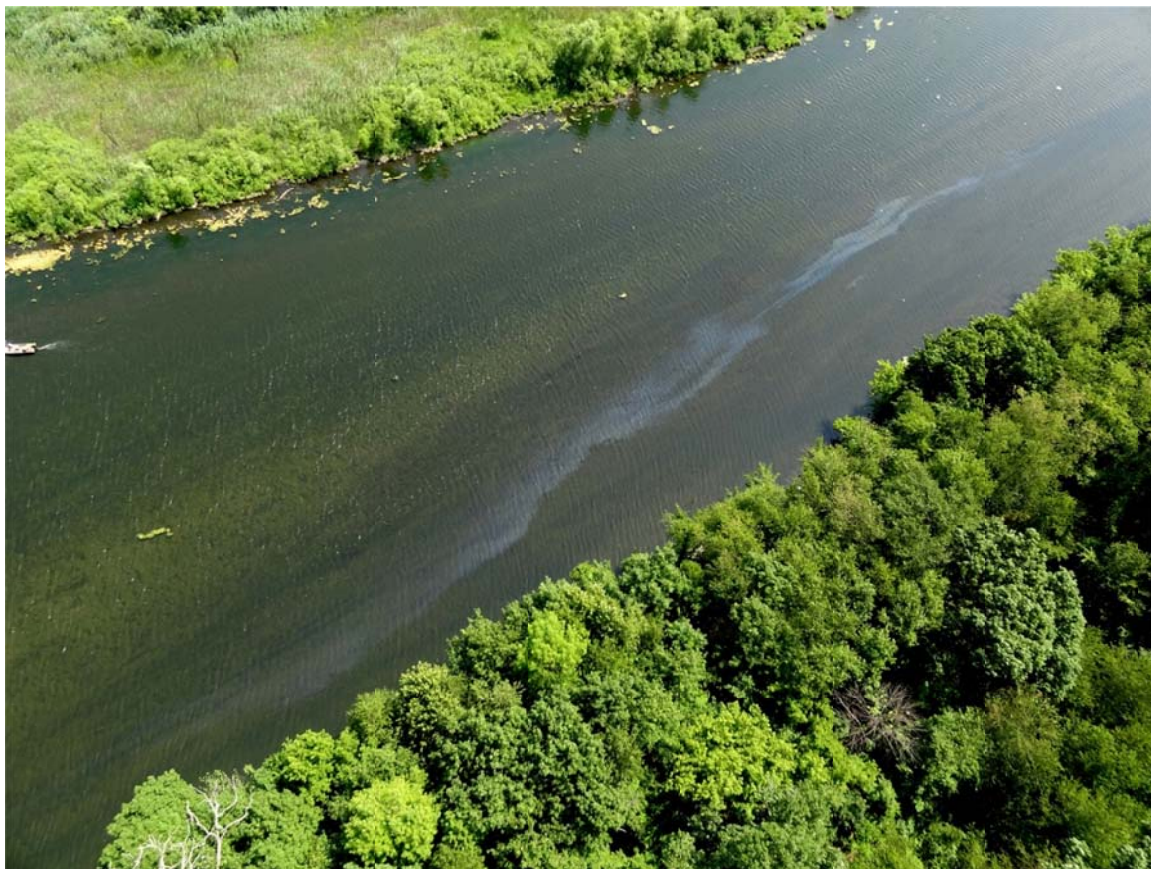
6. Sheen observed along southern shore downstream from C0.4 boat launch on return to Marshall, sweeper boat near northern shore was notified.

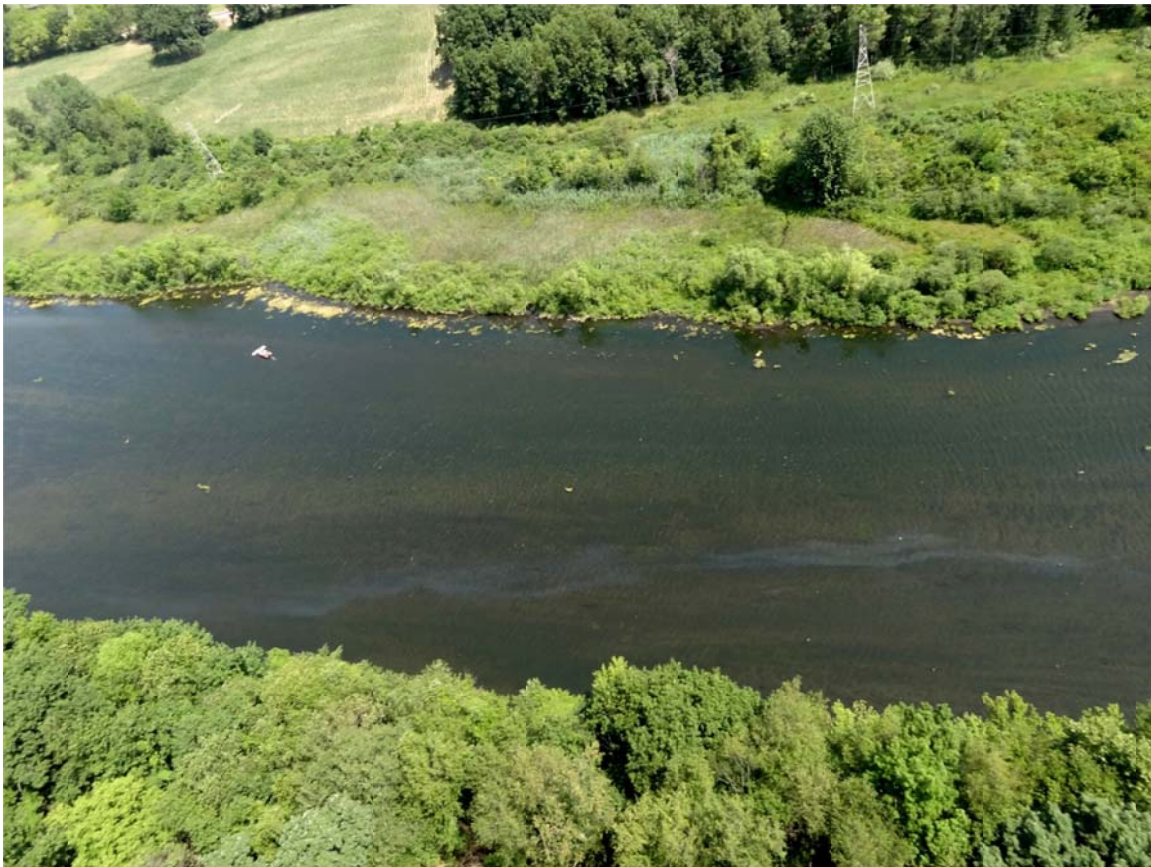
7. Sheen observed along southern shore downstream from C0.4 boat launch on return to Marshall, sheen response crew near northern shore notified.

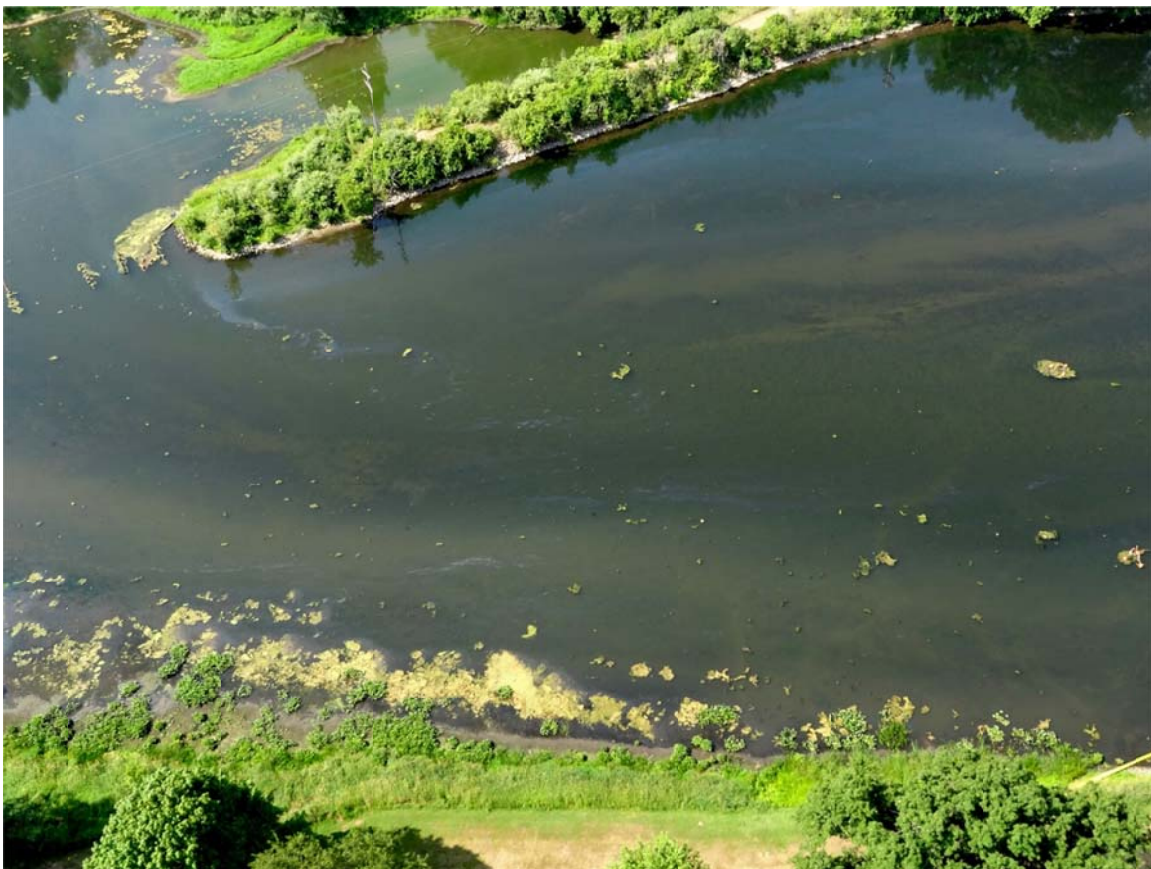
8. South peninsula above Ceresco Dam, observed sheen on upstream and downstream sides of peninsula. Sheen response crews were notified.

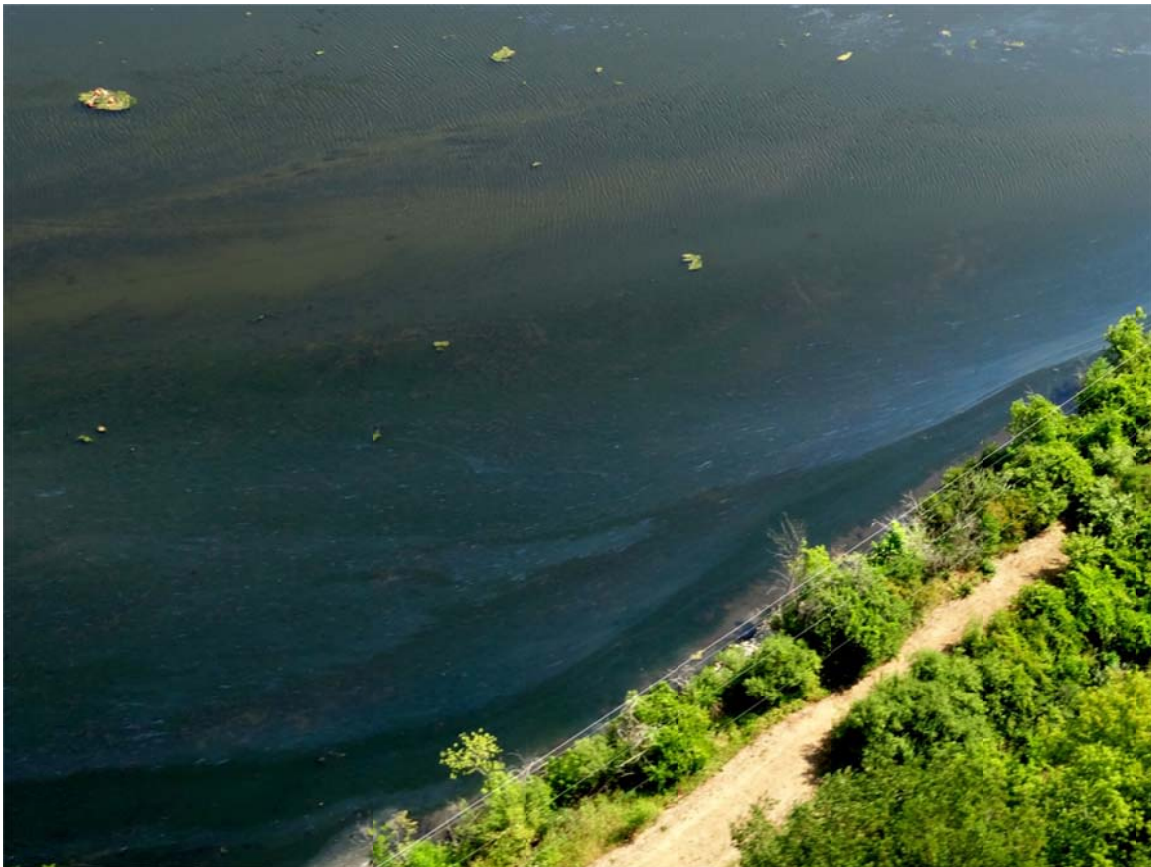
9. Sheen observed along southern shoreline above Ceresco Dam. Sheen response crews were notified.

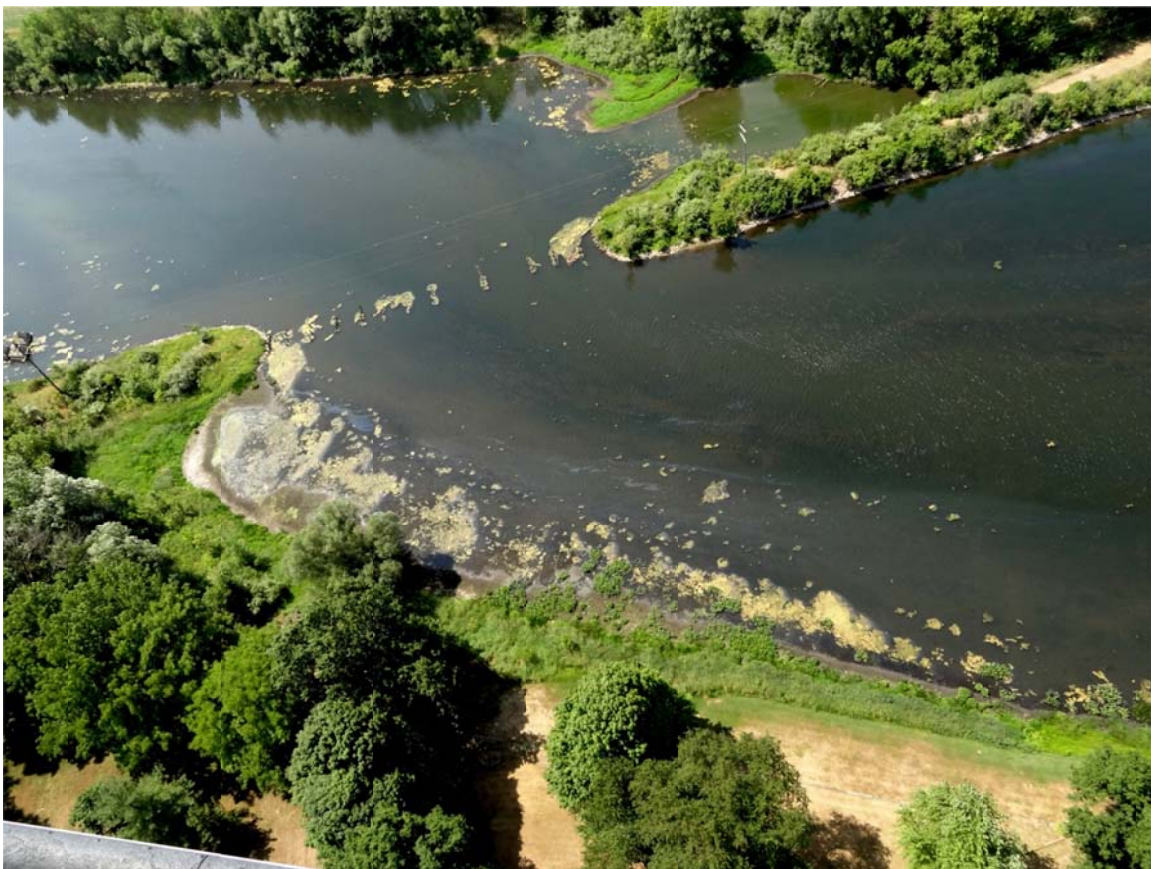
10. Observed sheen on downstream side of peninsula along northern shoreline on return to Marshall. Sheen response crews were notified.

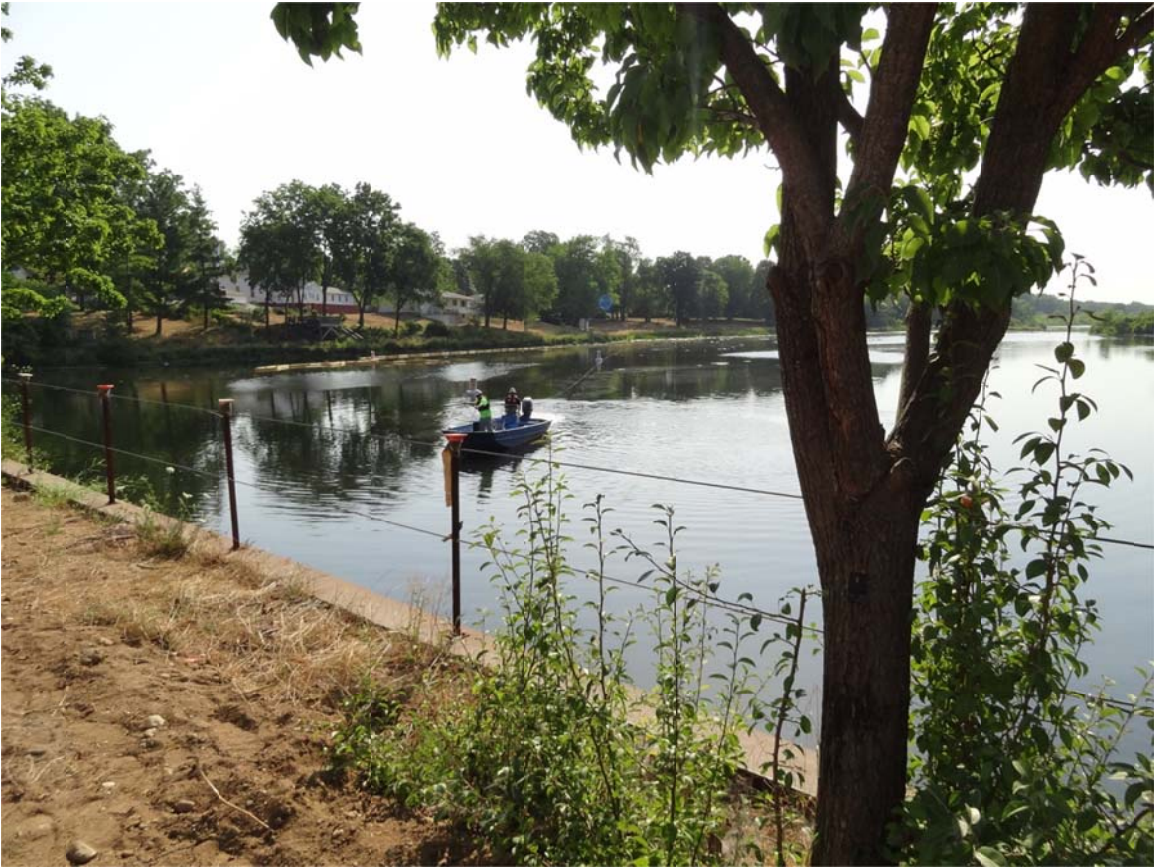
11. Crews installing control point boom at Ceresco Dam.

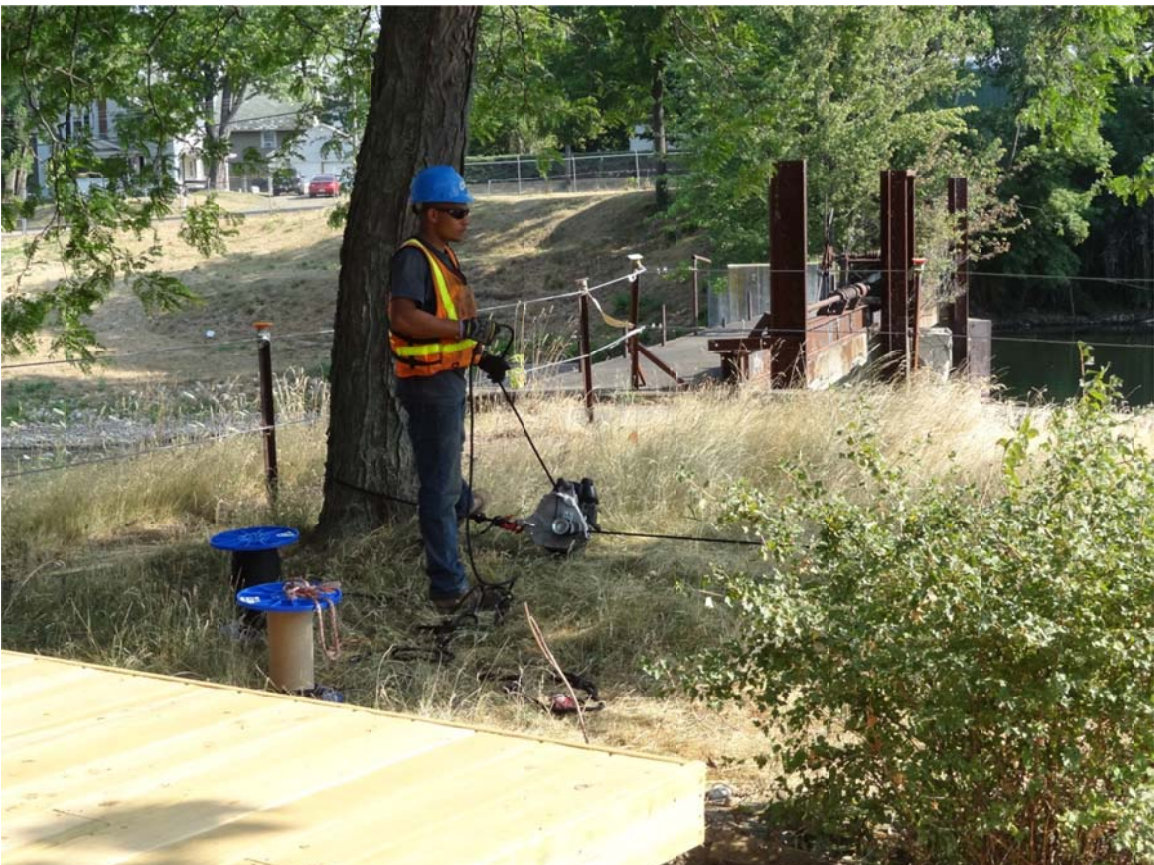
12. Crews installing control point support ropes at Ceresco Dam.

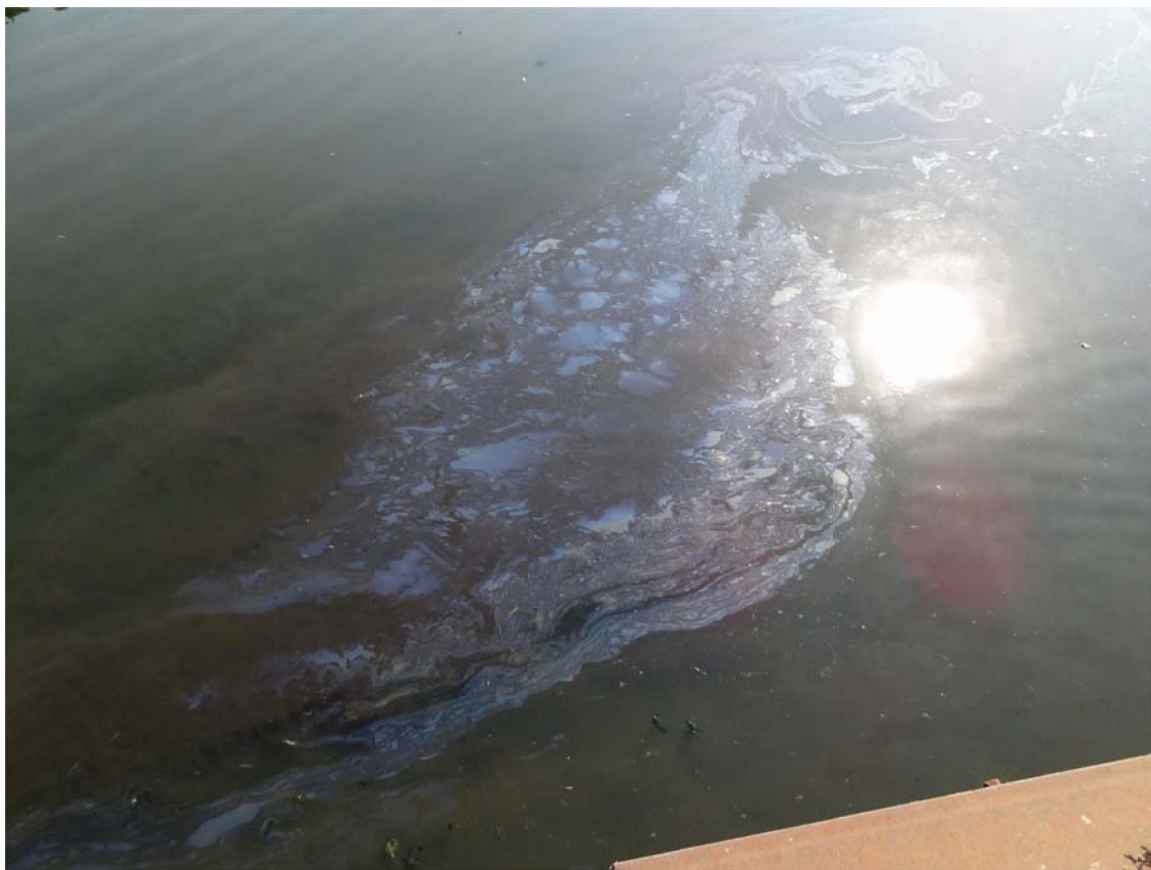
13. Sheen produced by boats installing containment boom at Ceresco Dam.

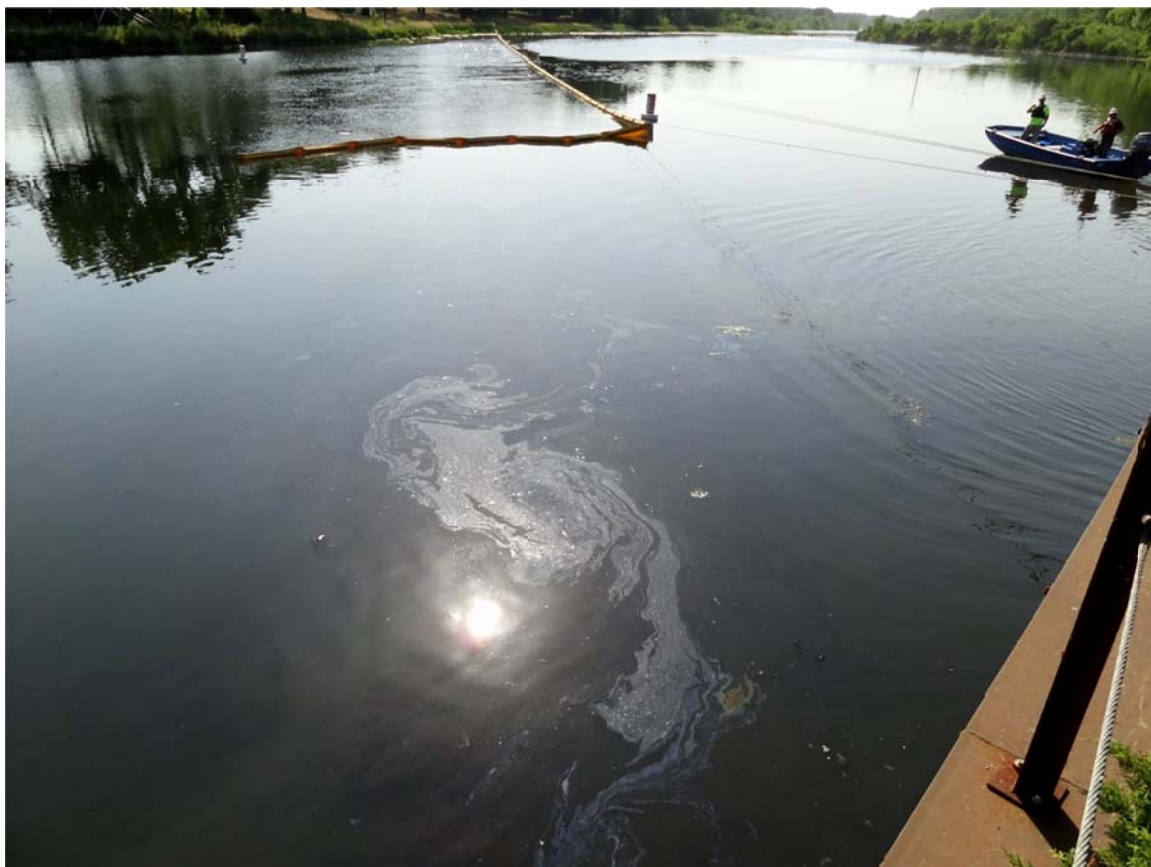
14. Sheen produced by boats installing containment boom above Ceresco Dam.

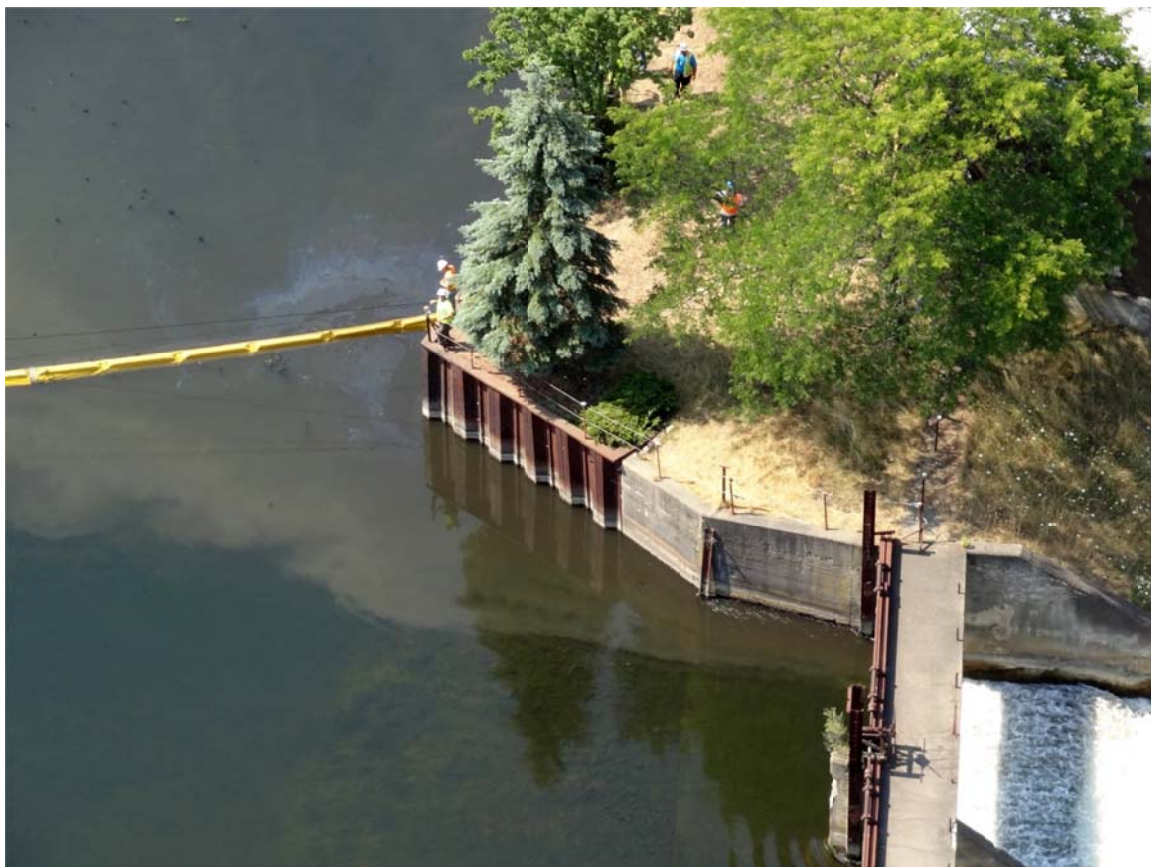
15. Containment boom and sheen along southern wall above Ceresco Dam.

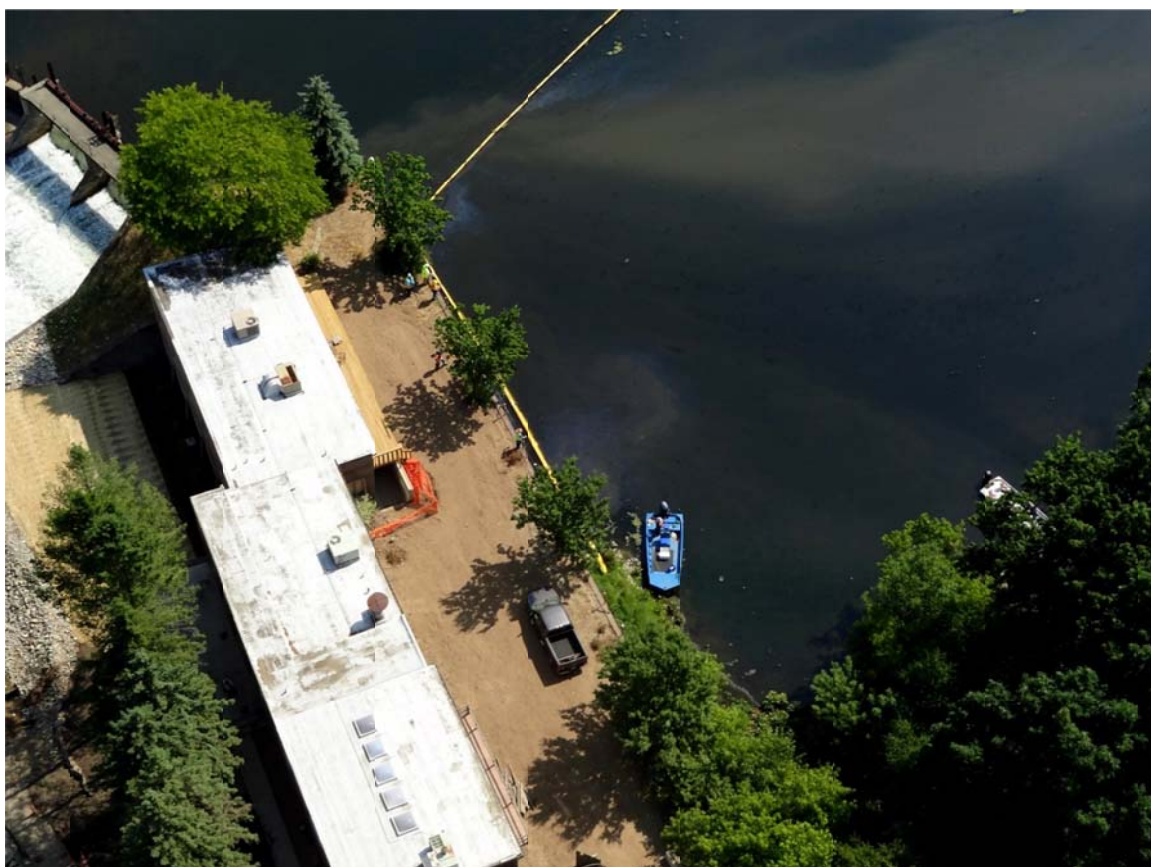
16. Sheen in southwest corner above Ceresco Dam, within containment.

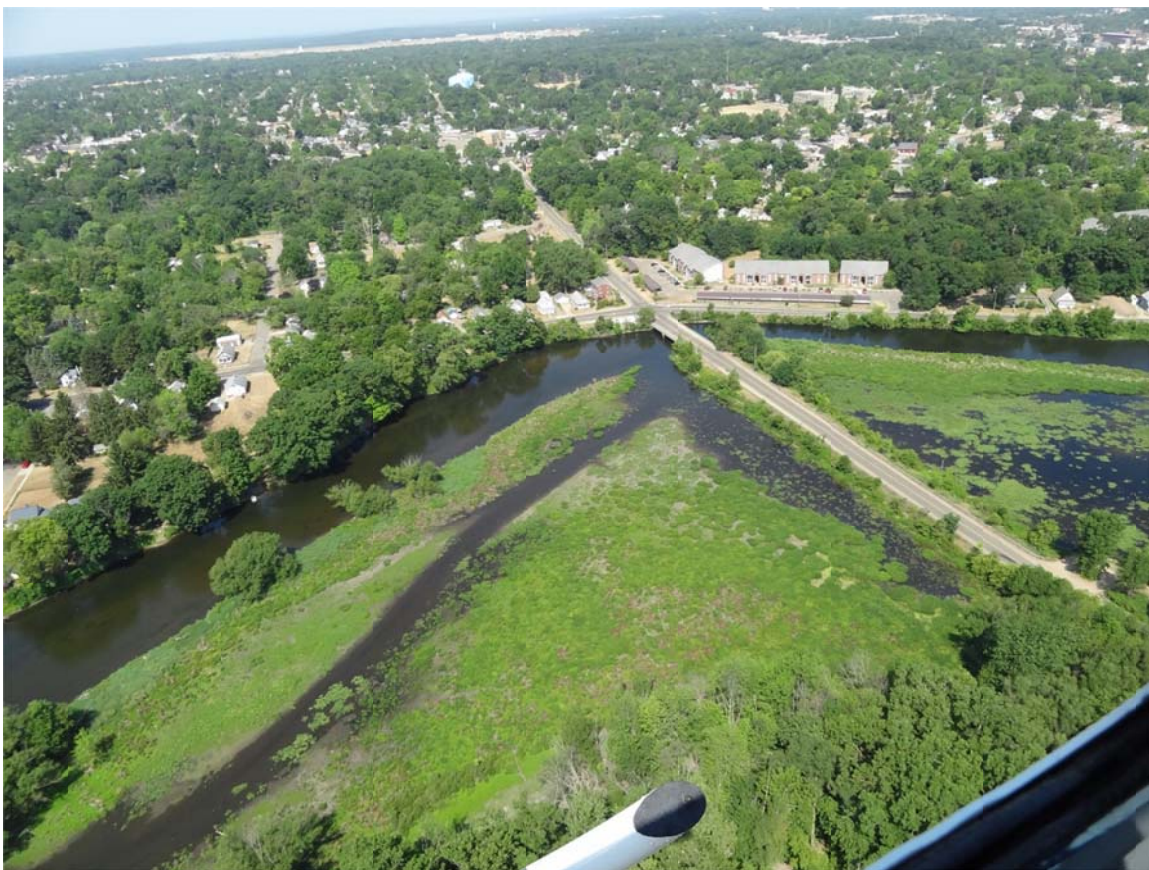
17. South end of Mill Pond, no sheen or activity observed.

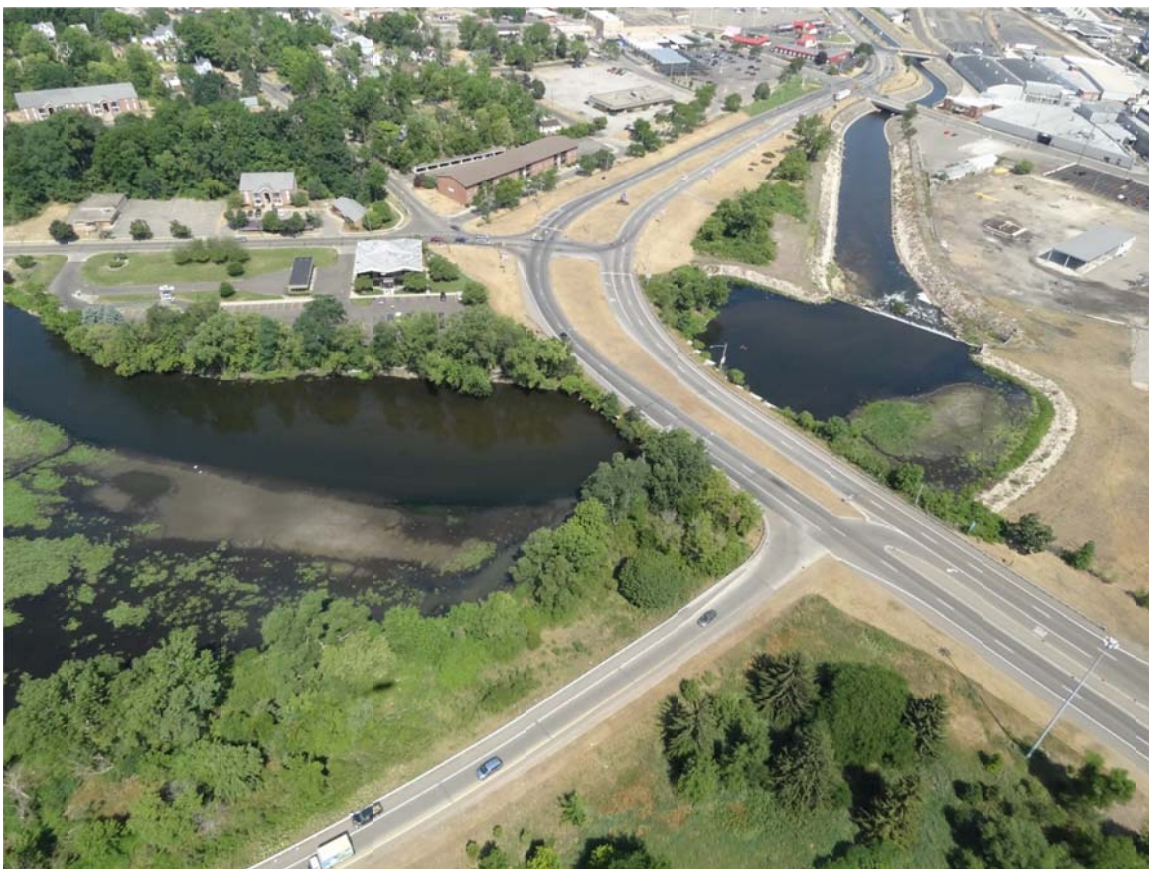
18. North end of Mill Pond and Battle Creek spillway, no sheen observed.

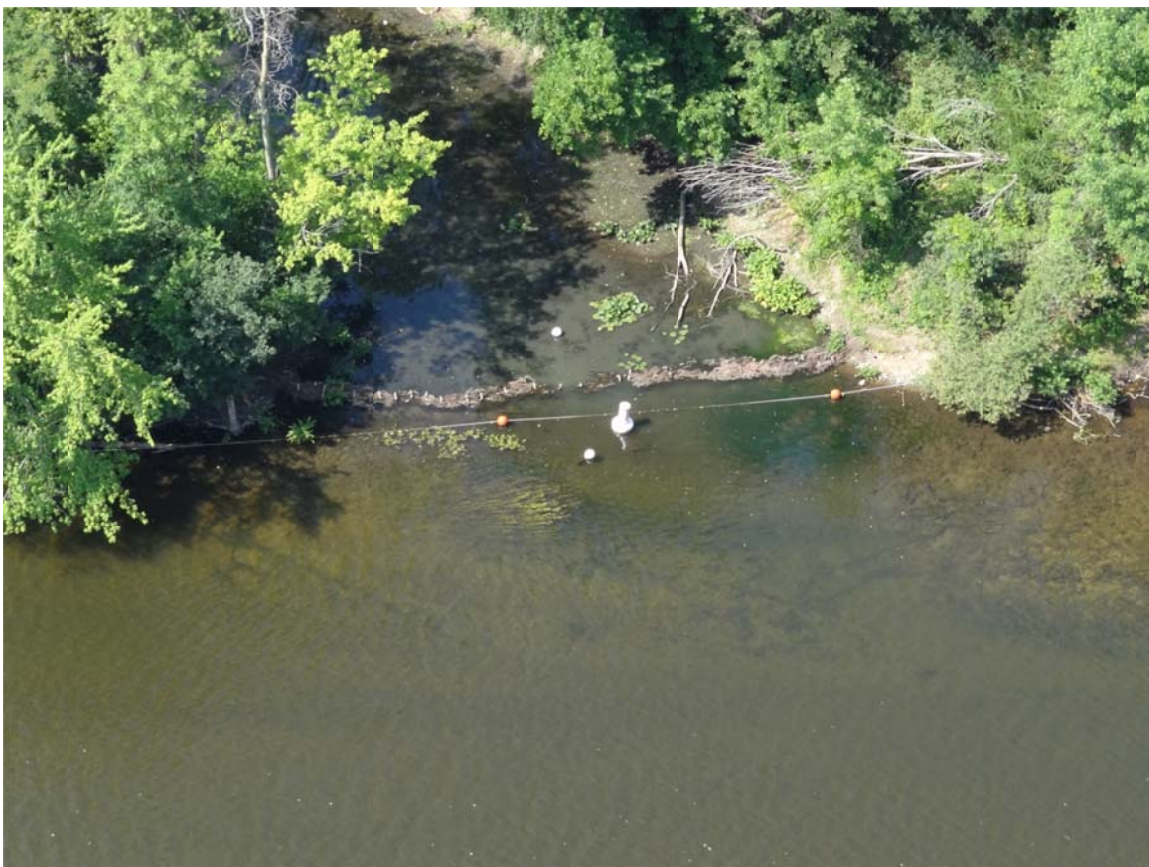
19. MP 19.25 sediment trap, no sheen observed.

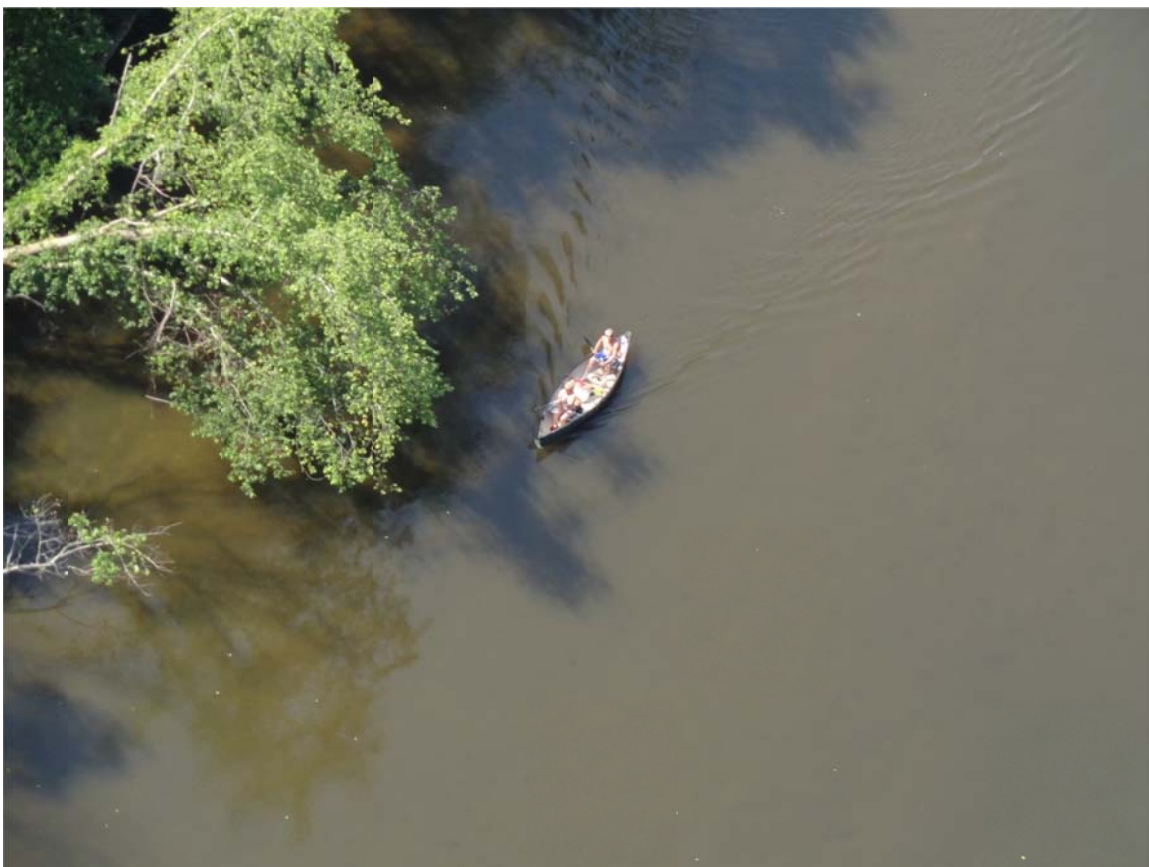
20. Canoers observed on river near Fort Custer.

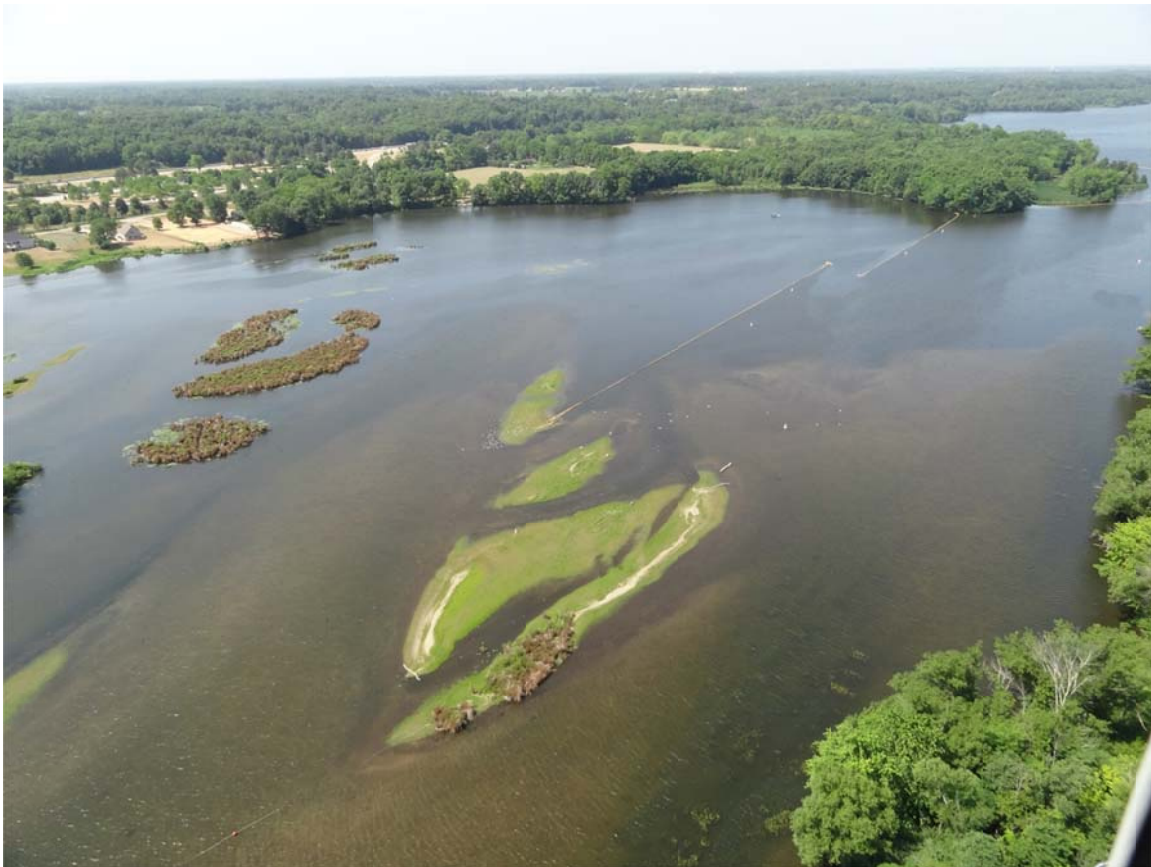
21. Morrow Lake Delta, sheen sweepers boat observed in southwest corner of delta.

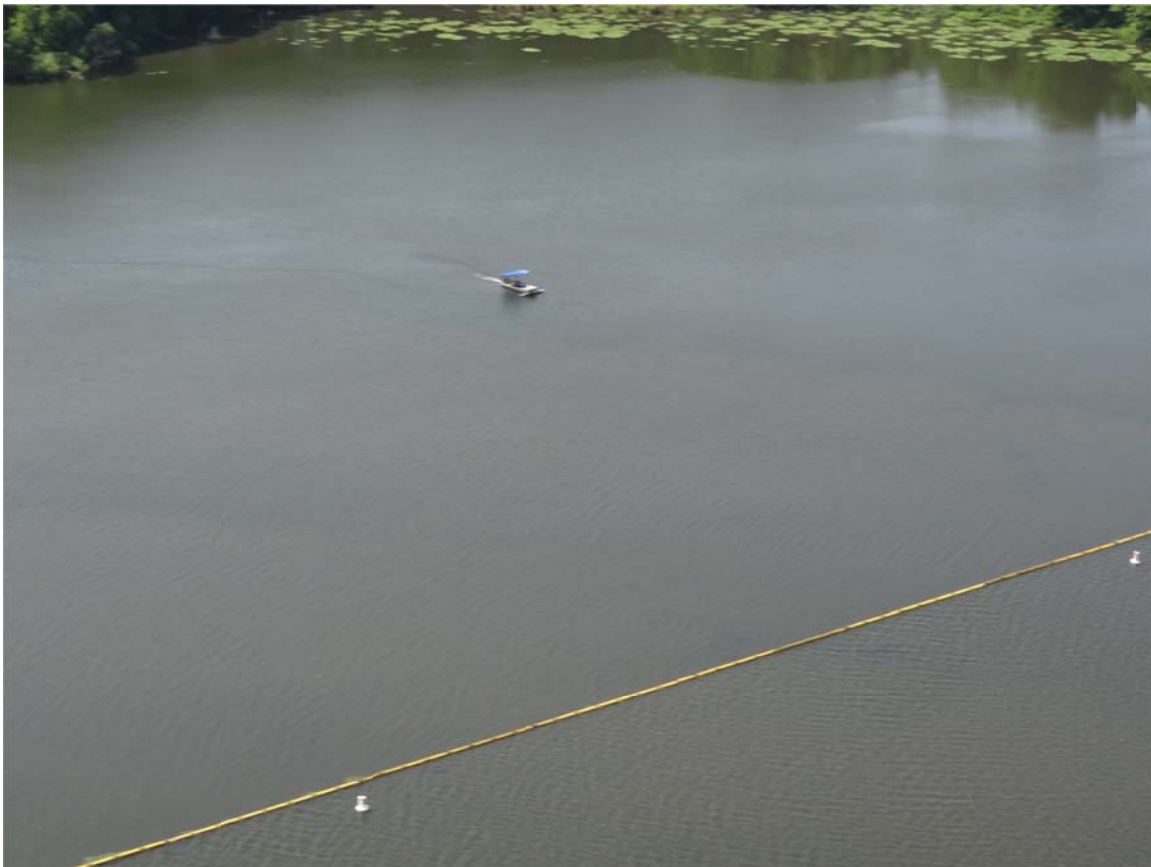
22. Sweepers boat operating in southwest corner of Morrow Lake Delta.

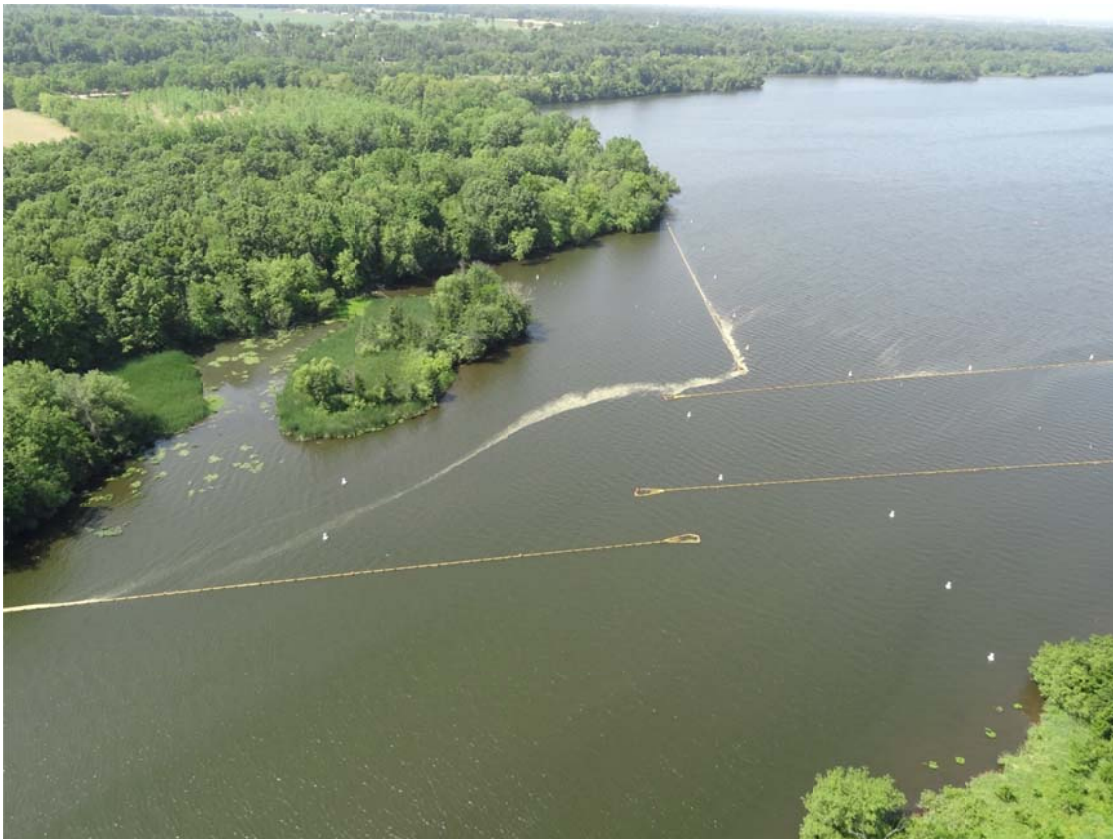
23. Current boom configuration at E4 control point. Organic debris observed on water surface along containment boom.
